Appendix C Photographs of Delta Levees (Chapter 5)

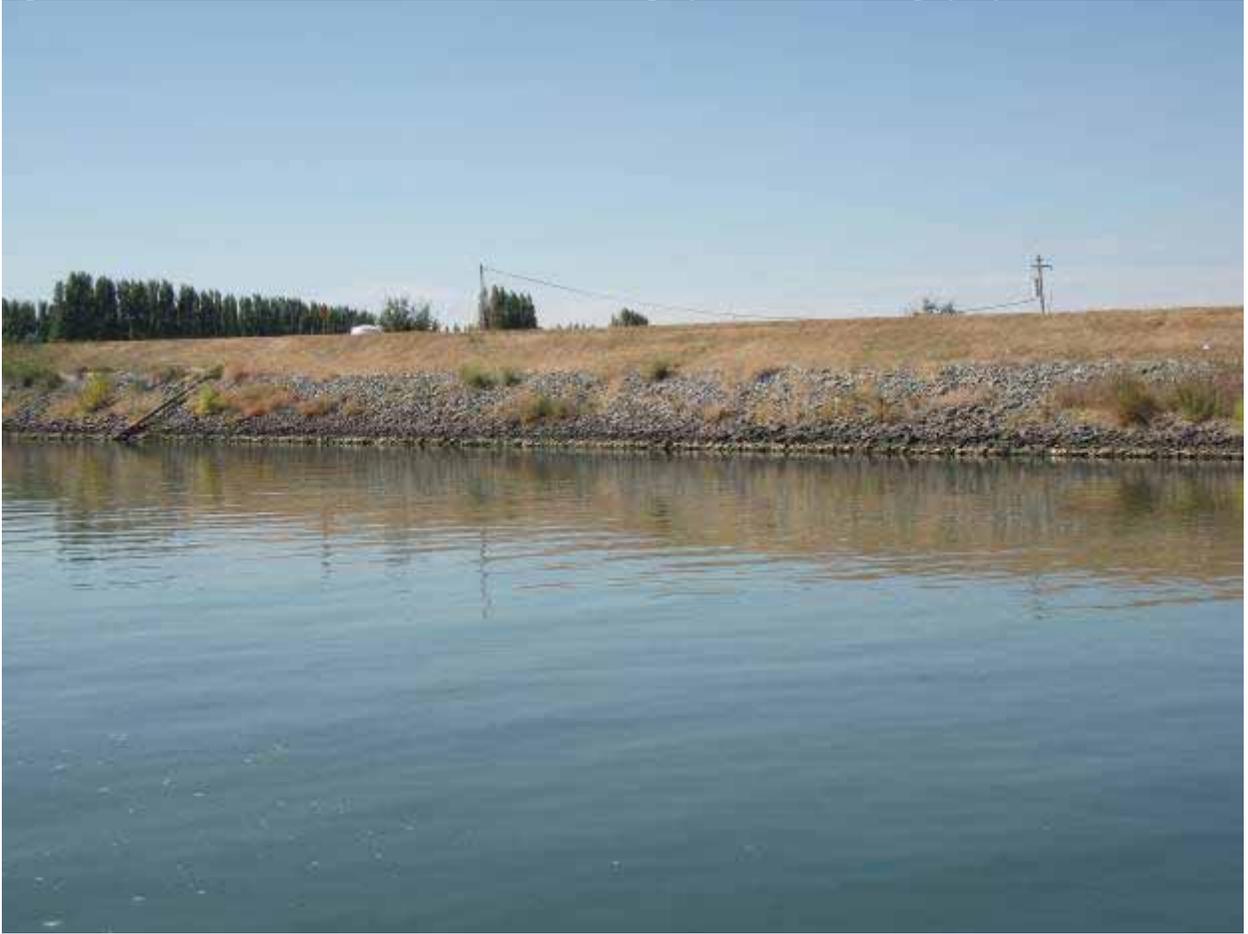
Figure C-1 Sacramento River south of Courtland, showing repair of erosion using rip-rap

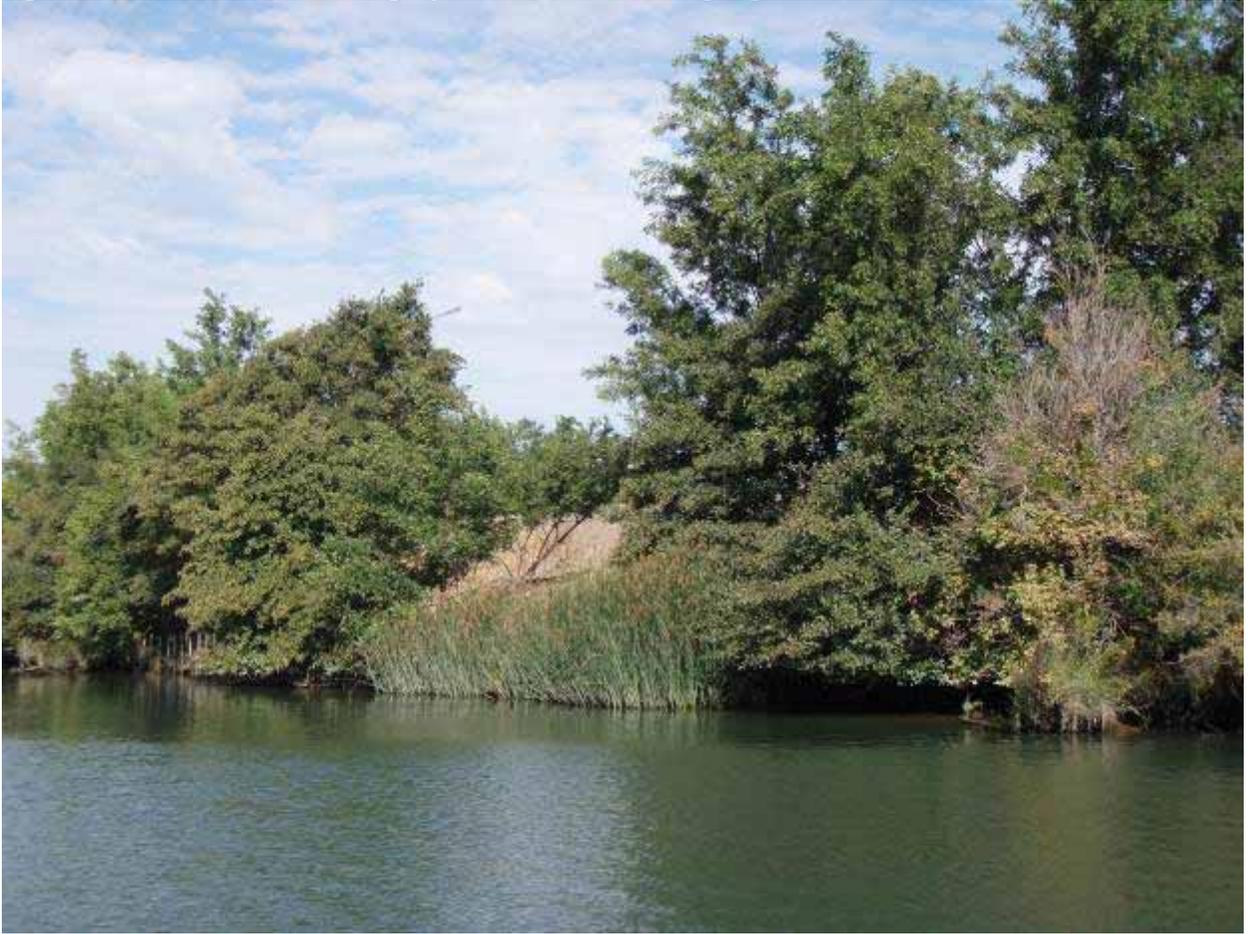
Figure C-2 - Merritt Island, showing repair of erosion site using vegetation

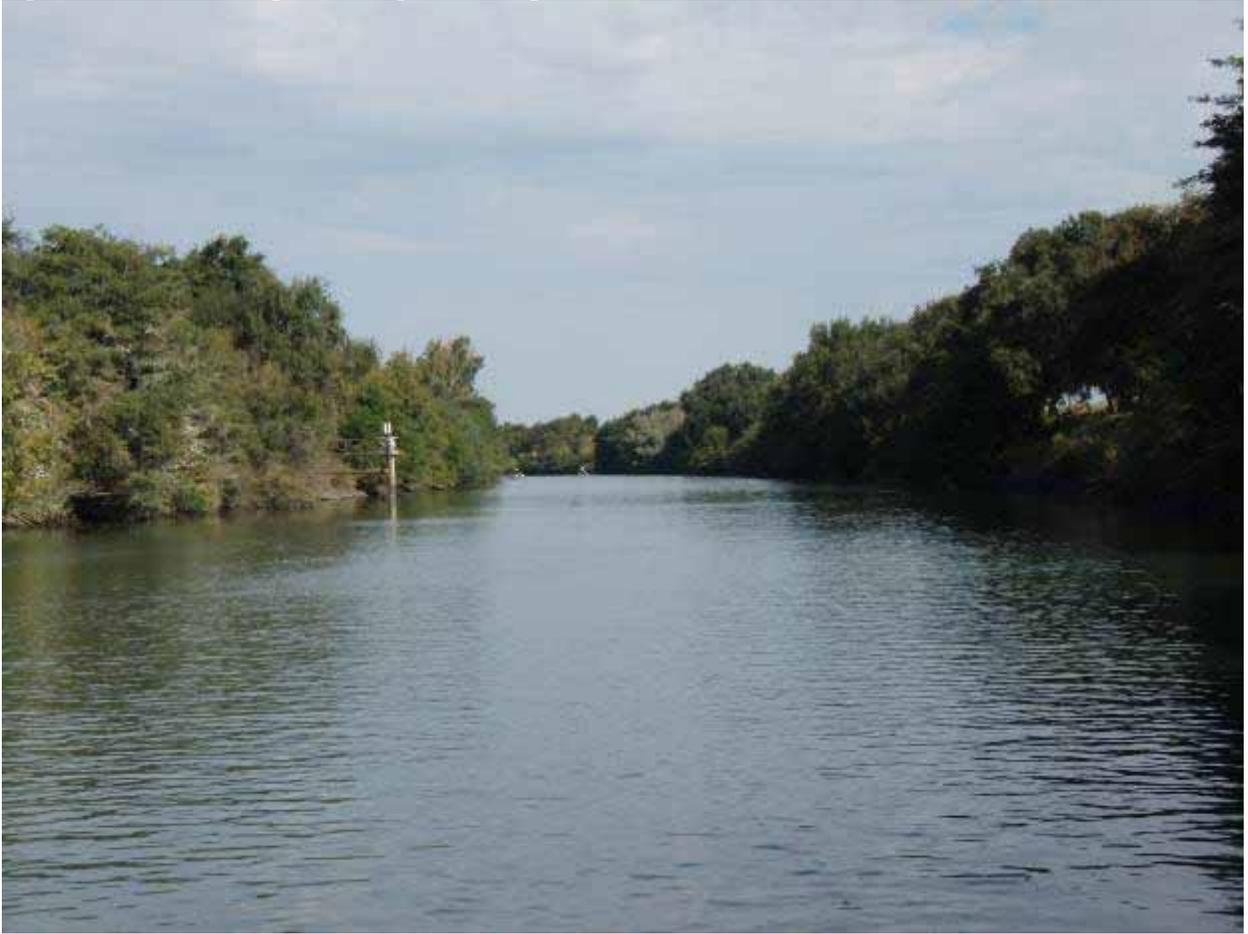
Figure C-3 - Sutter Slough, showing natural vegetation on levees

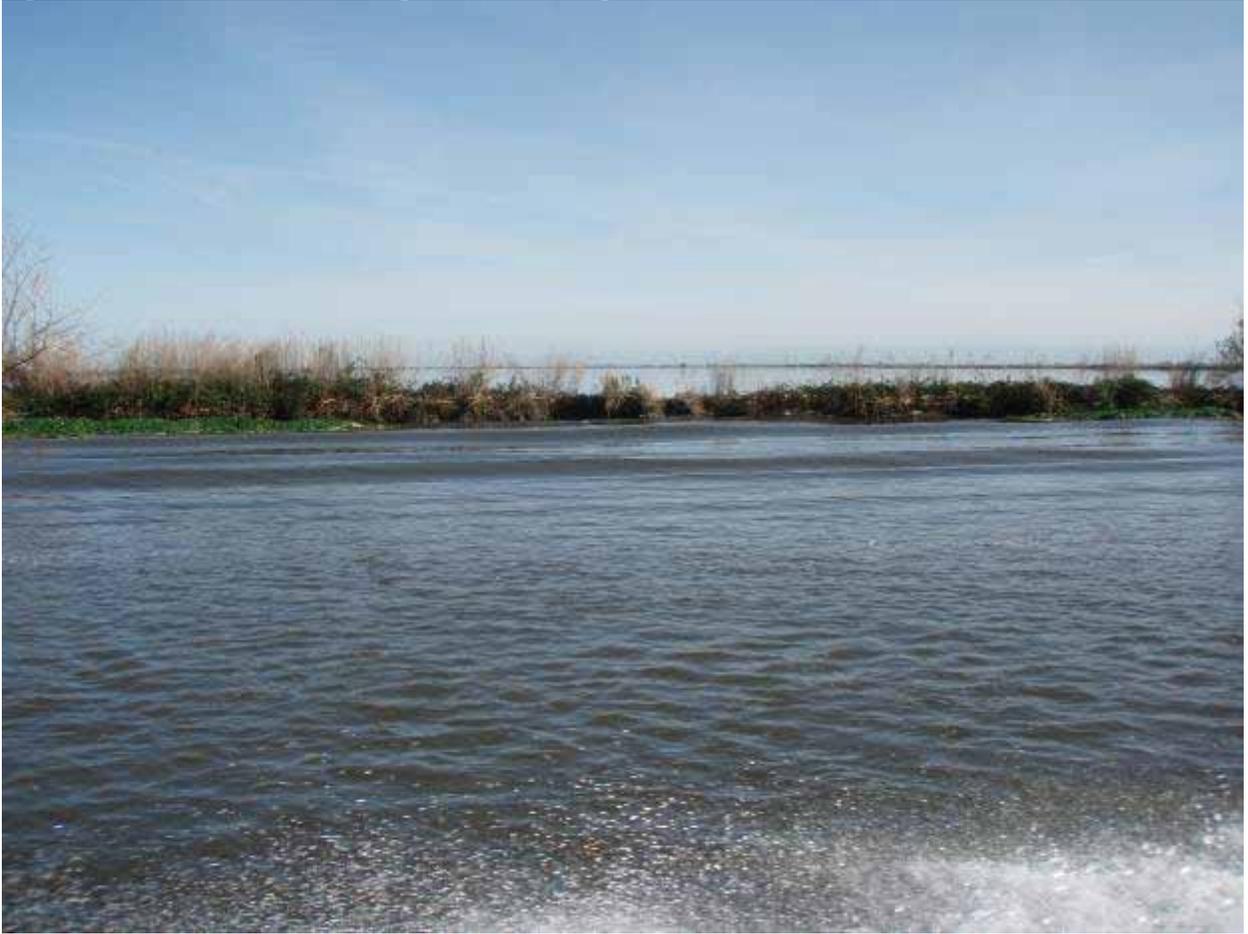
Figure C-6 - Mildred Island, showing effect of flooding on levee

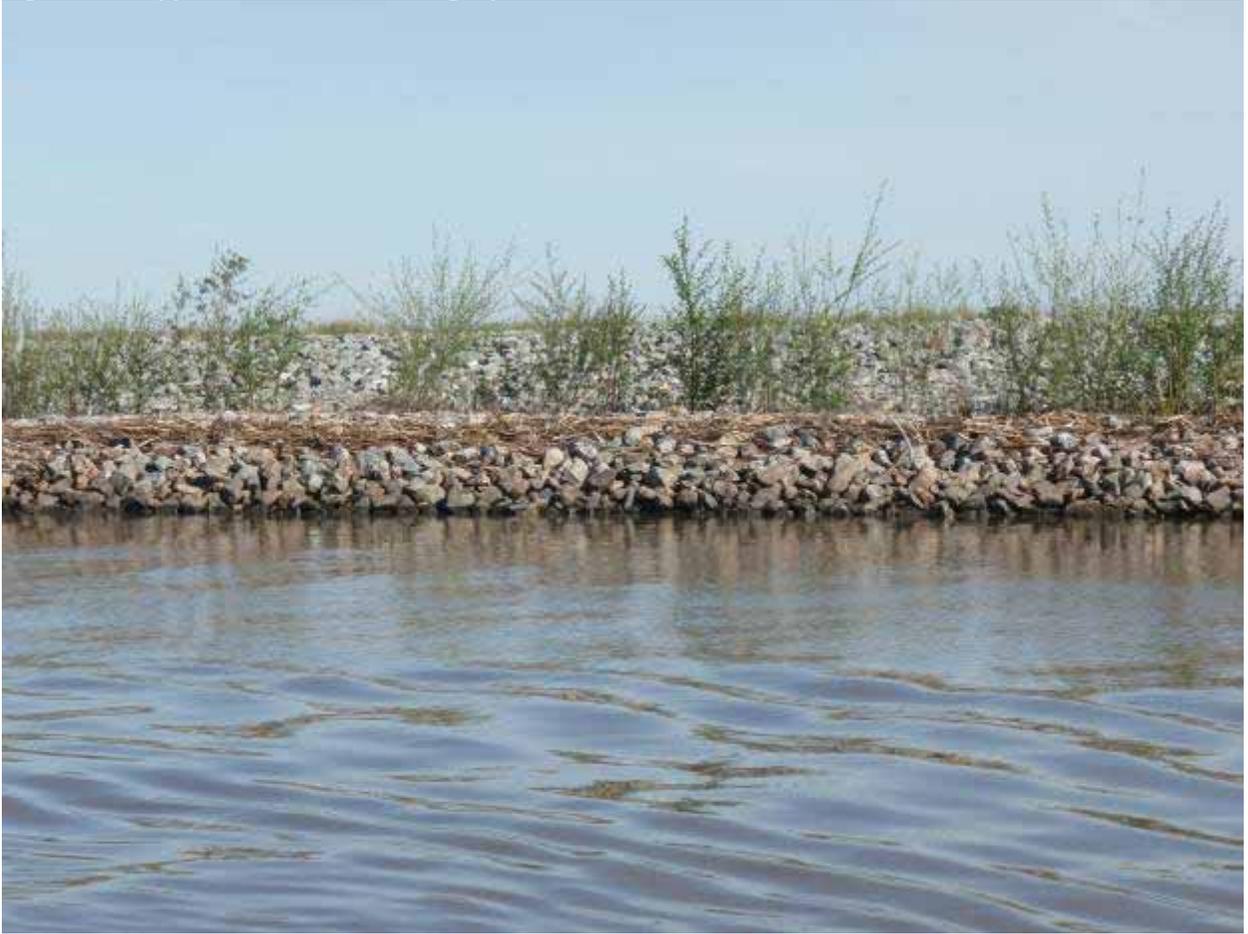
Figure C-7 - Upper Jones Tract, showing repair of 2004 breach with eco-bench

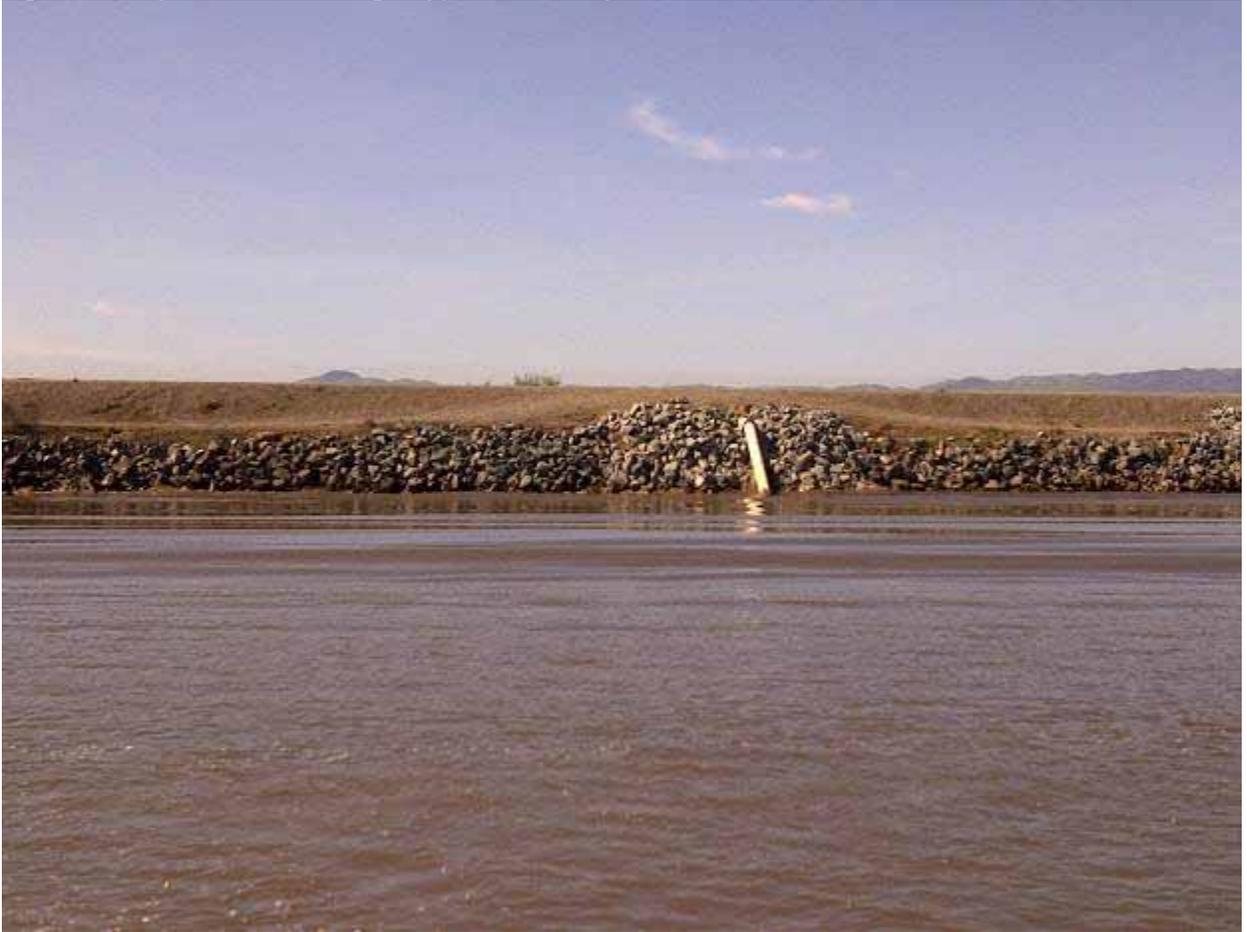
Figure C-8 - Byron Tract, showing stepped seismically-resistant levee

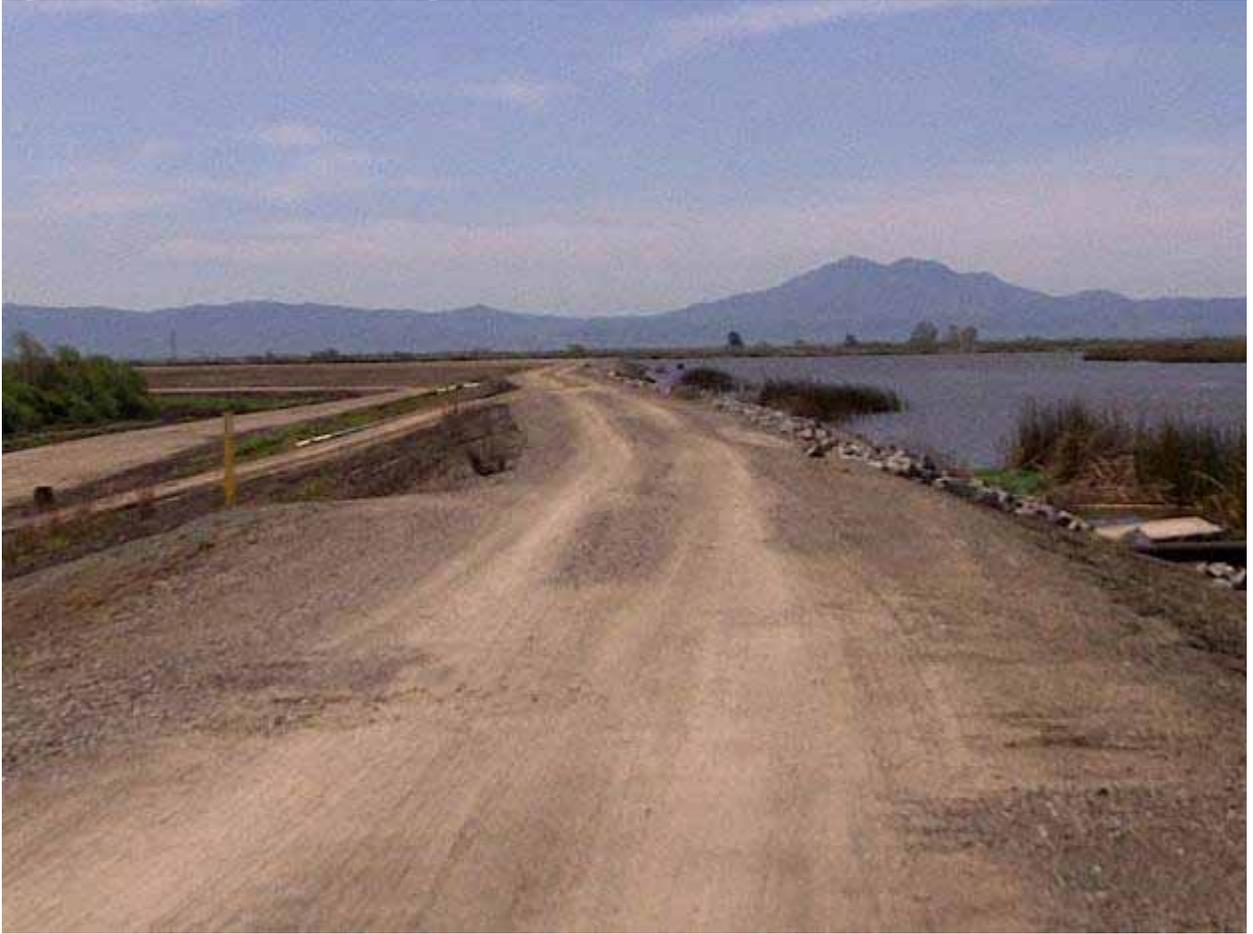
Figure C-9 - McDonald Island, showing PL 85-99 berm on landside
