# Understanding Environmental Processes in Real Time - Forest Fire and Water Quality

Valles Caldera, New Mexico, USA

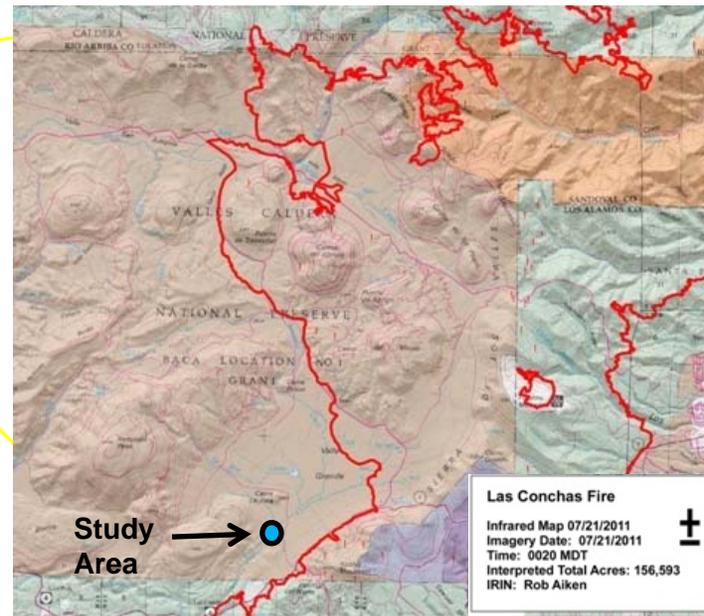
Jemez Watershed

- East Fork Jemez River in the Valles Caldera National Preserve (VCNP) in New Mexico
- High elevation third order stream
- Drainage area = 28 square miles
- Large valley (valles) meadows with surrounding forested catchment
- Las Conchas fire (June 26, 2011 to August 3, 2011) ; area burned ~ 157,000 acres

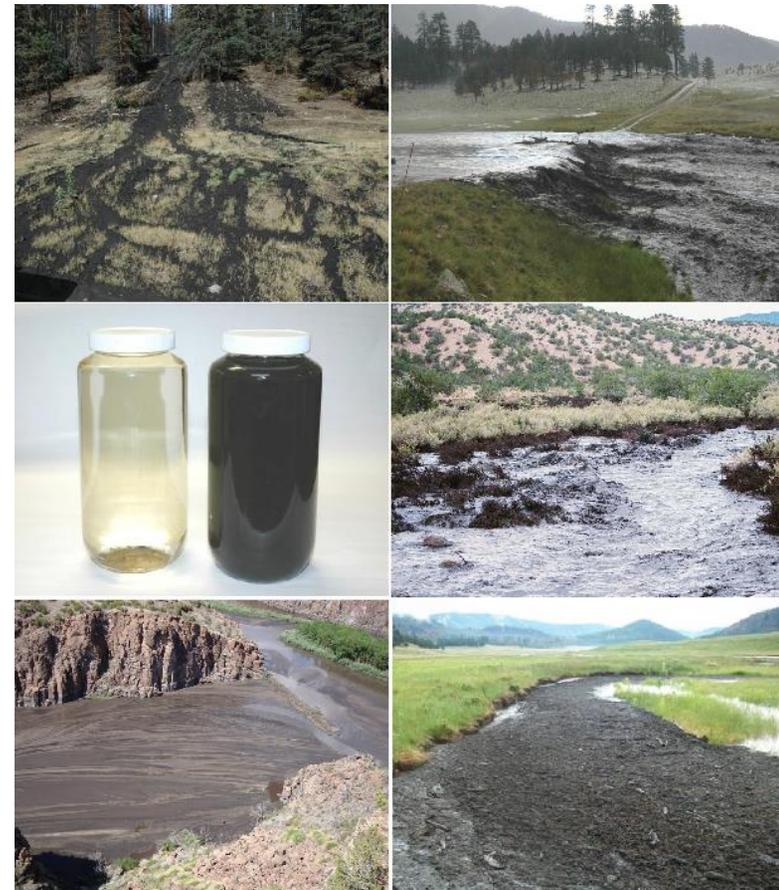
- Mobilized burn scar material (black carbon)
- Indios Creek flood flow – July 27, 2011
- Water clarity before and during flood event in Indios Creek
- Flood flow off the burn scar in Cochiti Canyon on August 22, 2011
- Sediment deposit at confluence of Rio Grande and Bland and Cochiti Canyons
- Burn material in Rio San Antonio in Valle Caldera National Preserve

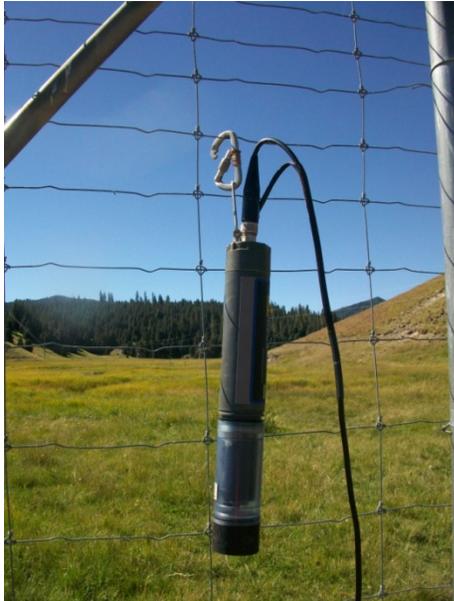
- YSI Sondes (SW and GW)**
- Temperature, DO, pH, SC, and Turbidity
  - 15-min intervals

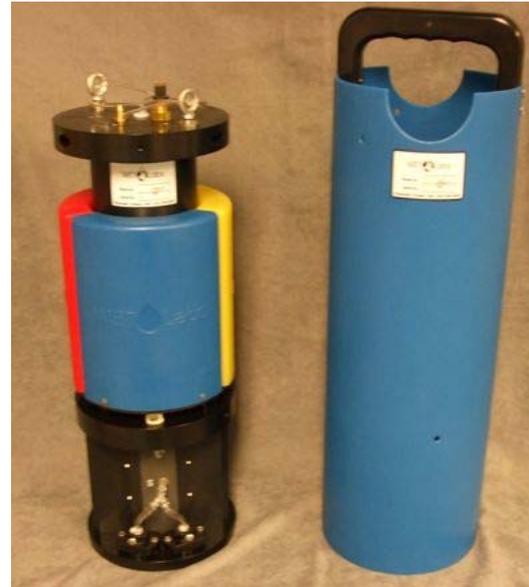
- WETLabs Cycle-P**
- $\text{PO}_4\text{-P}$
  - 1-hr intervals

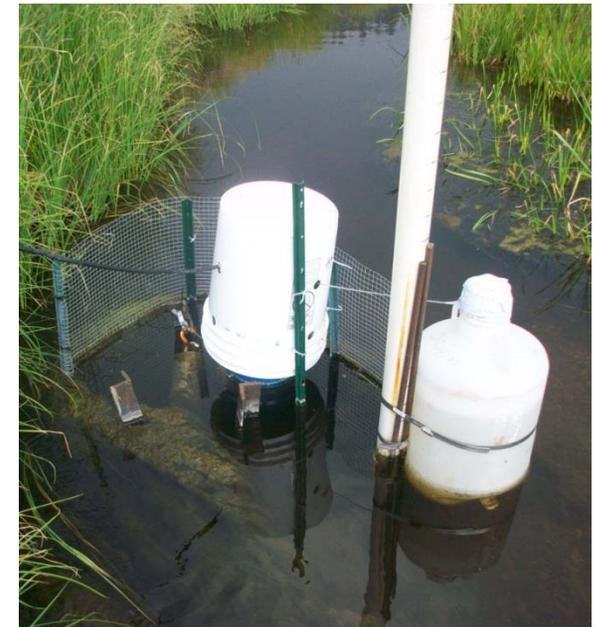
- Satlantic  
SUNA**
- $\text{NO}_3\text{-N}$
  - 30-min intervals

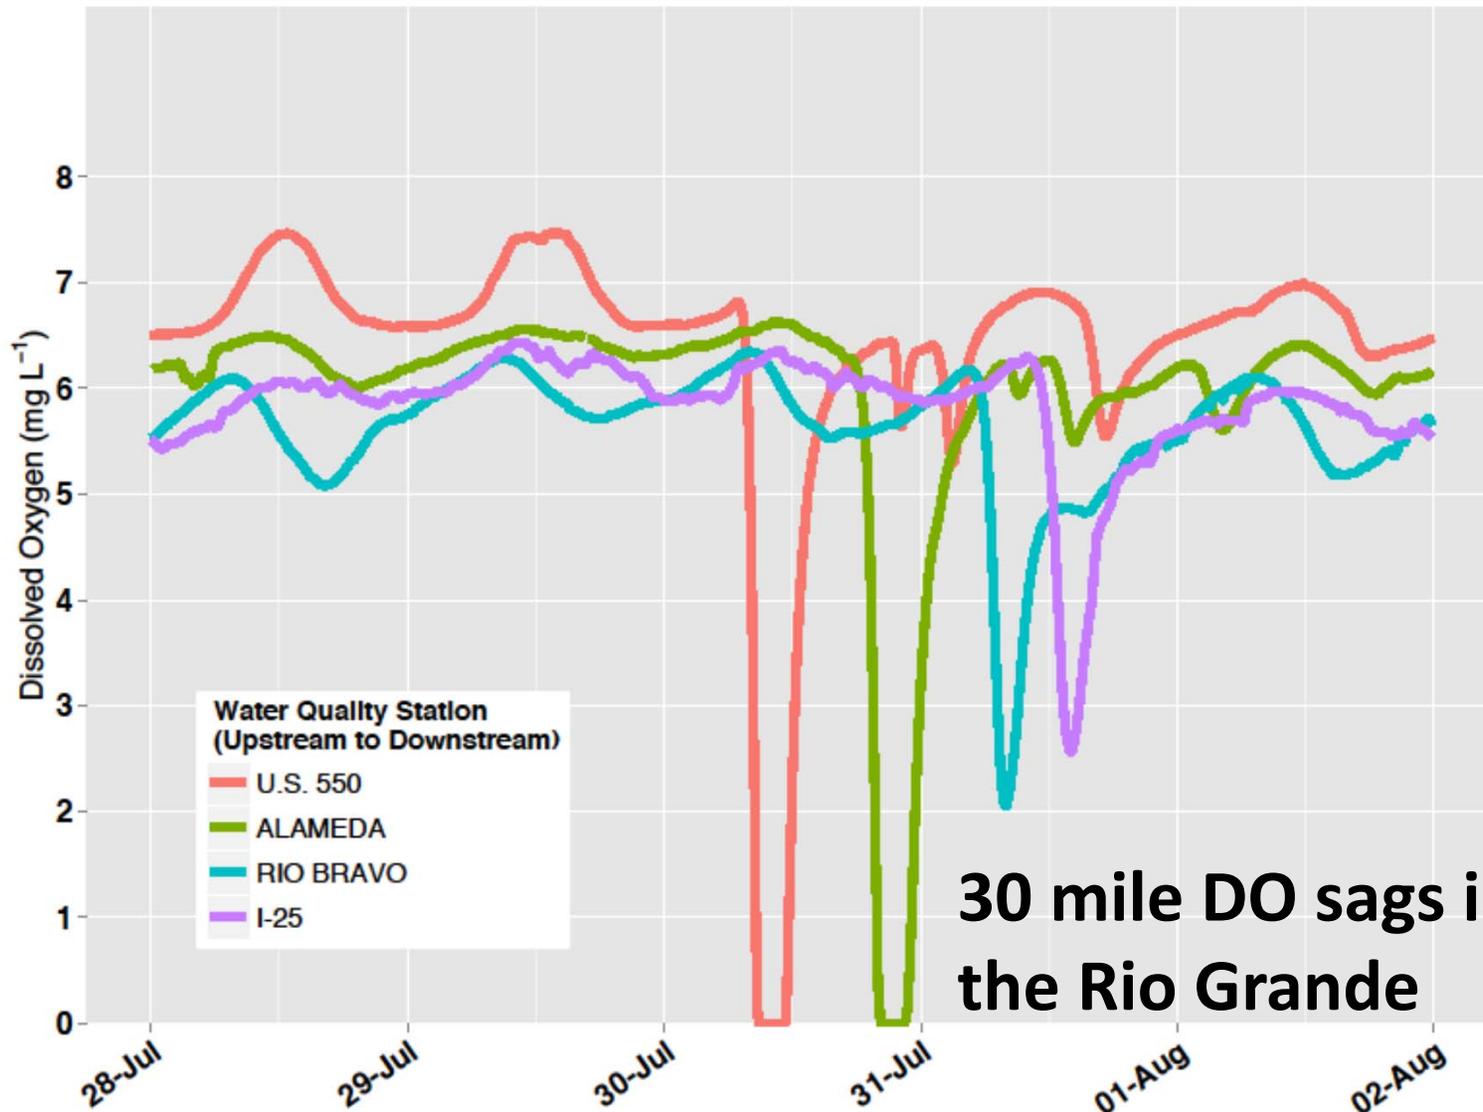
# Downstream DO Sags – Rio Grande

**30 mile DO sags in the Rio Grande**

**Severe water quality degradation downstream of burn scars will occur.**
