California Levee Vegetation Research Program (CLVRP)

Informational Circular No. 2: Summary of Research Completed to Date

December 12, 2011

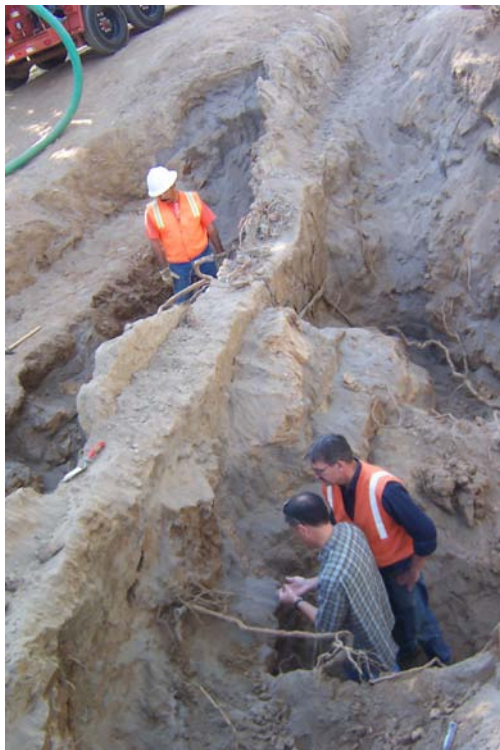
Exposed slurry wall (Pocket area levee)

Dr. Les Harder, a levee geotechnical engineer and researcher with HDR, Inc., has excavated trenches in a Sacramento-area levee to study tree root penetration into an 18-year-old soil-cement-bentonite (SCB) wall designed to cut off water seeping through the levee. Excavations in 2009 revealed that roots from a large black walnut tree growing at the top of levee had been encountered during the original construction of the wall and were cut or broken at the edge of the wall by construction equipment in 1991. However, over time, many of the cut roots had regenerated new branch roots which were

observed to grow laterally along the outside edge and within the outer few inches of the SCB wall – sometimes for distances of up to 10 feet. The 18-inch-thick SCB wall was also observed to have small, vertical cracks. In some cases cracks were exploited by small roots growing along the outside portion of the wall, at times penetrating through the SCB wall. In 2010, Dr. Harder undertook a follow-up slurry wall trenching investigation along the same SCB wall opposite valley oak and cottonwood trees. The trenches opposite valley oak trees showed no significant root penetration into the levee at a distance of 15 feet or more. A separate excavation in this area, however, revealed that cottonwood roots had penetrated the levee (both perpendicular and parallel to the levee) from trees as far away as 50 to 100 feet. Similar to observations in 2009, several cottonwood roots penetrated the wall through small vertical cracks. In 2010 ground squirrel burrows were also observed in the levee and in the SCB wall. The burrows were found approximately 4 to 5.5 feet below the levee crown, and approximately 15 - 20 feet horizontally into the levee slope.

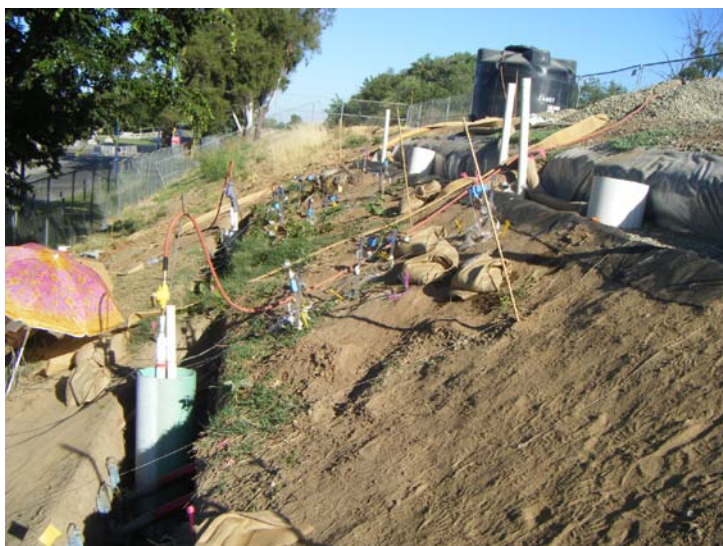
Decomposing stump field test site at Cal Expo

Between August and November of 2010, UC Berkeley researchers in the Department of Civil and Environmental Engineering conducted a field test to examine the effects of live and decaying root systems on seepage and slope stability on a levee bordering the American River near the California Exposition and State Fair (Cal Expo) grounds in Sacramento. The test consisted of constructing 45-foot-long parallel trenches on the landside slope above and below a decomposing eucalyptus stump. The trenches extended into a control area away from the stump and decomposing root system. The upper trench (2 feet wide by 3 feet deep) was filled with water and held at constant head to simulate and induce a slope-parallel wetting front through the levee. The lower trench was left open to view the effect on the progression of seepage caused by tree roots and other anomalies found in the trench walls. Piezometers and tensiometers installed across the test section of levee were used to describe the

wetting and flow patterns as they evolved within the levee during the test. Based on observations made during the flow test, wetting front and water flow patterns appeared to be dominated by flow through a network of shallow small mammal burrows. Though intermittent gaps associated with decomposing roots were observed, the gaps did not result in preferential water flow between the upper and lower trenches. Advancement of the wetting front appeared to be delayed in the area of the stump. Instrument data and preliminary computer simulations support the basic patterns observed in the field test.

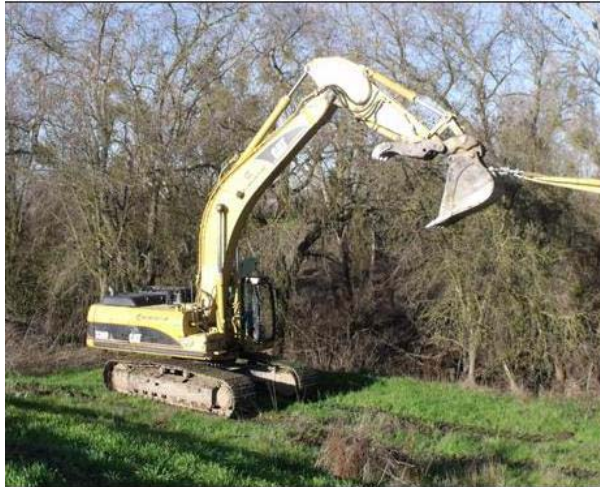
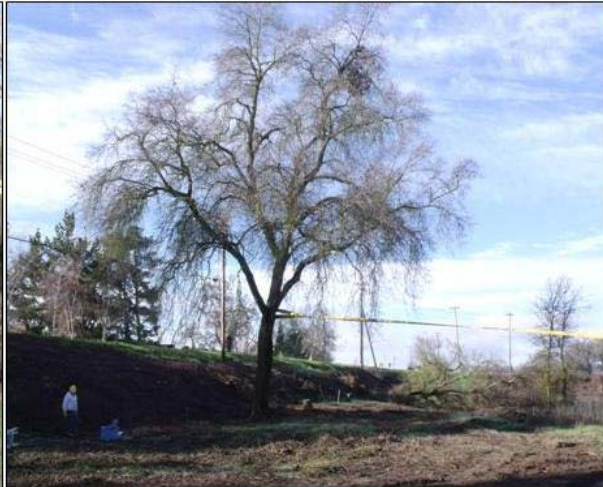
trees of different sizes and species, Dr Chris Peterson and his team from the University of Georgia instrumented and winched trees until they broke or fell. Valley oak and Fremont cottonwood were selected at four locations in the Central Valley. Trees from 6 to over 39 inches in trunk diameter at breast height were winched down using a strap and winch system, augmented by heavy machinery for the largest trees. Tree strength increased with tree diameter, as expected. The forces required to winch the trees ranged from 1 to nearly 22 tons of pull. Surprisingly, despite stronger wood and presumably deeper root systems, valley oak trees were only slightly stronger than cottonwoods, for a given tree size. Trees on riparian flats (rather than on levee slopes) were much more likely to uproot than similar trees on engineered, sloping substrates. Both cottonwoods and valley oaks exhibited uprooting as well as trunk breakage. Winching downhill resulted in no significant difference in tree strength compared to winching across slopes of the levees. Pulling force necessary to topple trees allowed formulation of estimates of critical wind speeds that would have blown down the study trees. Among the 69 trees for which such estimates are possible, only two had estimated critical wind speeds < 75 mph, and those trees were small. The largest trees were the most windfirm: among the study trees > 16 inches in trunk diameter (at 4 ft. above ground), most had estimated critical wind speeds above 100 mph. Given recorded history of high winds in California's Central Valley, the researchers estimated the likelihood of high winds that

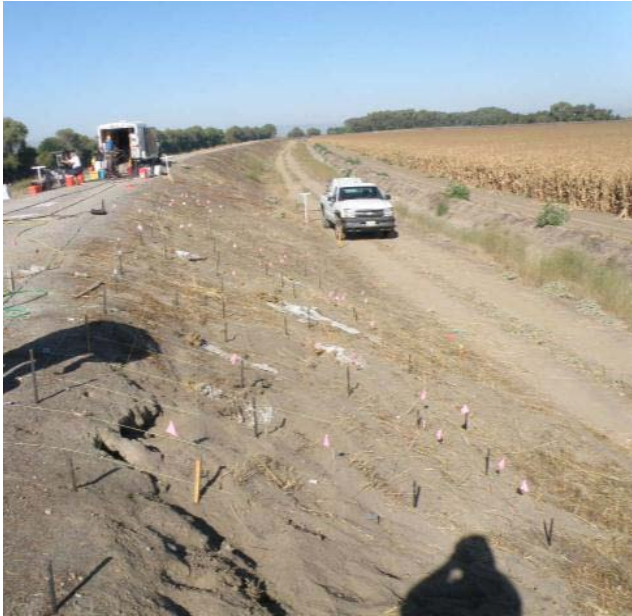
Levee site pre excavation

UC Berkeley recently completed field work for a burrow grouting study to ascertain the extent of mammal burrows on a Sacramento River levee segment near Kirkville, CA with no woody vegetation. The objectives of the test were twofold: to assess the extent and architecture of the mammal burrow networks in a previously un-grouted sandy levee; and to study the efficacy of current California Department of Water Resources (DWR) grouting techniques. Two methods of grouting were used: first, DWR performed their regular grouting procedure by injecting a standard gray cement-bentonite grout into the largest burrows that were visible on the levee surface. Subsequently, a urethane-based chemical grout, colored with pink dye, was injected in perforated stand pipes arranged in a 1.2 m x 1.2 m grid pattern to fill burrows potentially not fully grouted in the first round and other holes with no visible surface expression. As the levee was excavated burrows grouted with standard grout were painted green to distinguish them prior to T-LiDAR imagery taken by USGS. The data collected will be used to estimate the volume of voids created by burrowing mammals within the embankment, differentiating between the two types of grout (pictures next page).

Preliminary observations of the test exposed a complex system of burrows that seemed to be highly dependent on soil stratigraphy. The excavations on the waterside slope exposed a single large burrow near the toe, and the excavations on the landside slope exposed a series of interconnected squirrel burrows that extended both horizontally and vertically for several tens of feet in the direction parallel to the levee alignment. No tunnels were found that extended through the levee from landside to waterside.

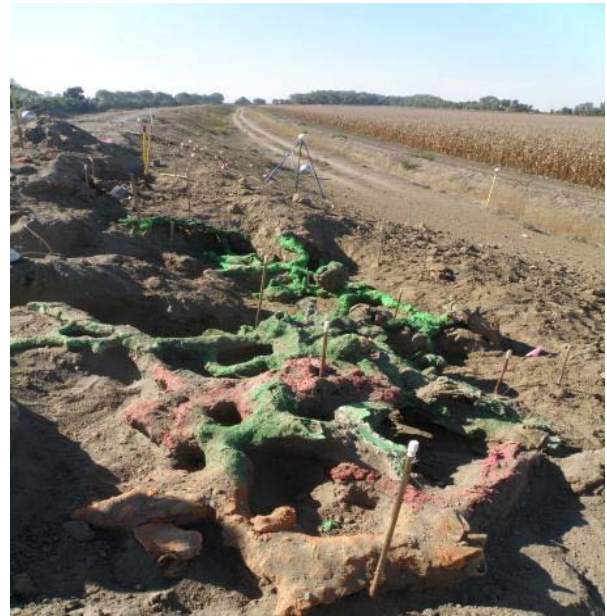
Post excavation - site with grouted excavated burrows
